QUESTION | MRI REPORTS ARE OFTEN 2 PAGES LONG. WHAT ARE THE KEY FEATURES YOU LOOK FOR ON AN MRI SCAN OF A PATIENT YOU SUSPECT HAS AN ACL INJURY?

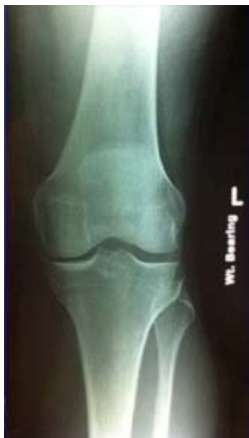
Weight Bearing AP

- Weight bearing AP (looking at alignment and for arthritis),
- Lateral (looking at patella height and tibial translation)
- Notch view (looking at the flexion portion of the condyles) and
- Skyline view (looking at the patella).

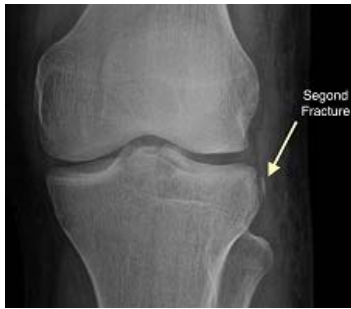
Second Fracture

1. A Segond fracture (described by Dr Paul Segond in about 1879¹) where a fleck of bone is seen adjacent to the tibia. This almost certainly indicates an avulsion near the area of insertion of the anterolateral ligament and in most studies is pathognomonic of an ACL rupture.
2. The deep sulcus (terminalis) sign, which is seen as a depression on the lateral femoral condyle at the terminal sulcus. This is the junction between the weight bearing *tibial* articular surface and the *patellar* articular surface of the femoral condyle. If you have a bony injury in this area (rather than just a bone bruise) it tends to indicate a higher energy of injury to the knee and the longer-term outcomes tend to be worse when this is present.

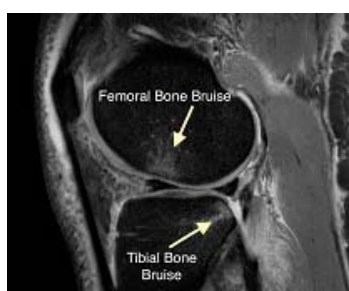
Sagittal view - bone bruise
ACL tear MRI.

Start laterally in the knee and move medially on the T2 weighted images. The first thing we usually see is bone bruising on the femoral condyle (although this may not be present in all injuries and on recurrent instability episodes - about 70% of people with an ACL injury have a bone bruise). This bruising is due to the joint subluxation that happens and is seen (1) in the lateral femoral condyle overlying the anterior horn of the lateral meniscus and (2) on the posterior aspect of the tibial plateau. The femoral condyle bone bruise is seen at the anterior aspect of the lateral femoral condyle between the femoral condyle and the trochlear (where an impaction fracture can take place).

As we move more medial we start to see fluid in the joint, which is consistent with bleeding from an ACL tear. It is also common for there to be a tear to the posterior horn of the medial meniscus with an ACL injury.

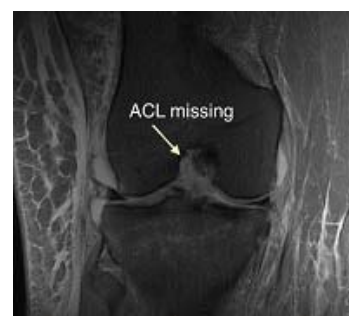
Coronal View missing
ACL

We then move to the coronal images. The normal ACL will be traced from the postero-superior and lateral origin to its antero-inferior and medial insertion. As we start to move more posterior we look for bone bruising and we start to see a stump of a torn ACL. Instead of seeing normal contour of the dark ACL substance, we start to see more a balled-up appearance. In this view we can also see the injury to the posterior horn of the medial meniscus.

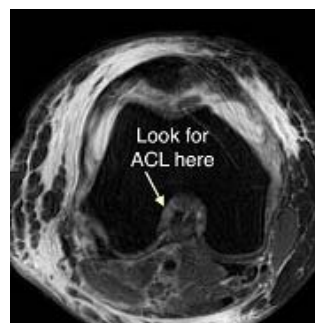
Axial View ACL

Finally, we look at the axial views, although these are not as useful when looking at ACL tears. The ACL is an oval low intensity structure which becomes elliptical in the midsubstance. This is much harder to appreciate if the cuts are not in exactly the right plane. You can see if there is fluid present within the joint and you may be able to see the Segond fracture at the tibia on these images (depending on the slice thickness used).

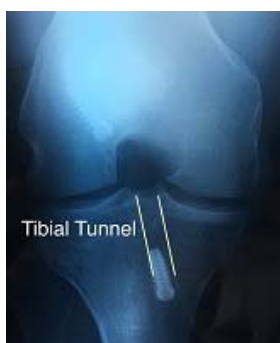
Tibial Tunnel marked

The Tibial Tunnel is best seen on lateral view knee with the knee in full extension. The anterior margin of the tibial tunnel should be behind a line drawn along the roof of the femoral notch (Blumensatt's line). This ensures that the graft is not impinged on by the bone with the knee in full extension. The center of the graft tunnel should be one-quarter to one-half the distance from the anterior to the posterior tibial cortex but this is more variable than the Blumensatt's line measurement. *In general if the tibial tunnel is too far forward it leads to graft impingement and if it is too far back it leads to ongoing instability.*

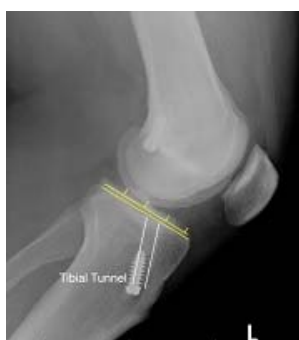
Tibial Tunnel with plateau markings
