# A Systematic Approach to Magnetic Resonance Imaging Interpretation of Sports Medicine Injuries of the Knee

Timothy G. Sanders,<sup>\*†</sup> MD, and Mark D. Miller,<sup>‡</sup> MD

Magnetic resonance imaging is performed more commonly on the knee than on any other joint, and it is an excellent diagnostic tool that can aid in the evaluation of a host of sports-related injuries involving the ligaments, tendons, menisci, osseous structures, and articular surfaces. A thorough evaluation of the images, however, can be a daunting task, as the study often contains dozens of images obtained with multiple pulse sequences and in several imaging planes. A systematic approach will facilitate an accurate and timely evaluation of this complex examination and will ensure that all of the clinically relevant structures are adequately assessed. This article will provide a systematic approach to the interpretation of a magnetic resonance examination of the knee. The normal imaging appearance of each anatomical structure will be described, and the optimal pulse sequence and imaging plane for the evaluation of each structure will be discussed. Finally, the signs of injury will be described and illus

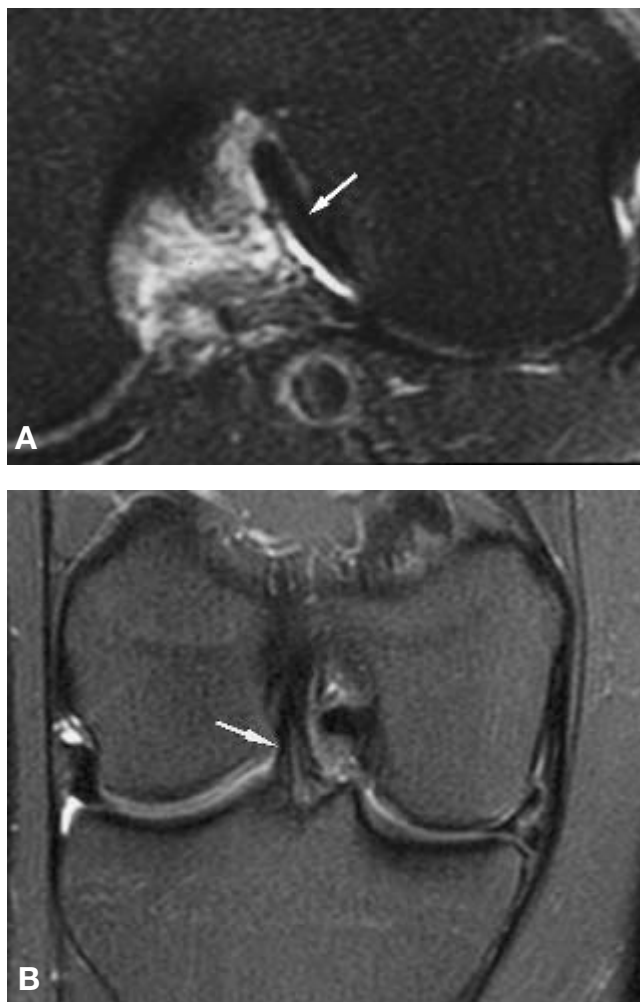
**Figure 2.** Normal ACL appearance in axial and coronal planes. A, T2-weighted axial image of the left knee through the level of the intercondylar notch demonstrates the normal appearance of the ACL (arrow) as it arises from the medial aspect of the lateral femoral condyle. Note that on the axial image, the normal ACL has an oval appearance at its proximal attachment site. B, T2-weighted coronal image of the right knee demonstrates the normal striated appearance of the ACL (arrow). The coronal image clearly depicts the proximal and distal attachments.

appearance in all 3 planes. Axial and coronal (Figures 2 A and B) images are especially helpful in evaluating the femoral attachment, whereas the coronal plane is also complementary in the evaluation of the midsubstance and tibial attachment. The integrity of the ligament is best assessed on T2-weighted or proton density images.

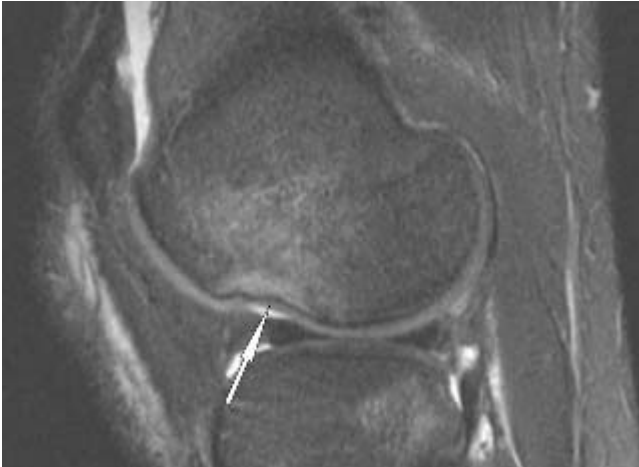
**Figure 7.** Deep sulcus sign. T2-weighted sagittal image demonstrates the deep sulcus sign, an impaction injury of the lateral femoral condyle that results from the impaction of the femoral condyle against the posterior tibial plateau during the pivot-shift injury. The sulcus must measure at least 2 mm deep to be considered abnormal.

- Deep sulcus sign: lateral femoral condyle (more than 2-mm deep) (Figure 7).
- Second fracture: capsular avulsion fracture of the lateral tibial plateau (Figure 8).
- Kissing contusions: anterior tibia and femur (hyperextension injury).
- Anterior drawer sign: anterior translation of tibia relative to femur.
- Buckling of PCL: nonspecific.
- Acute hemarthrosis: nonspecific.

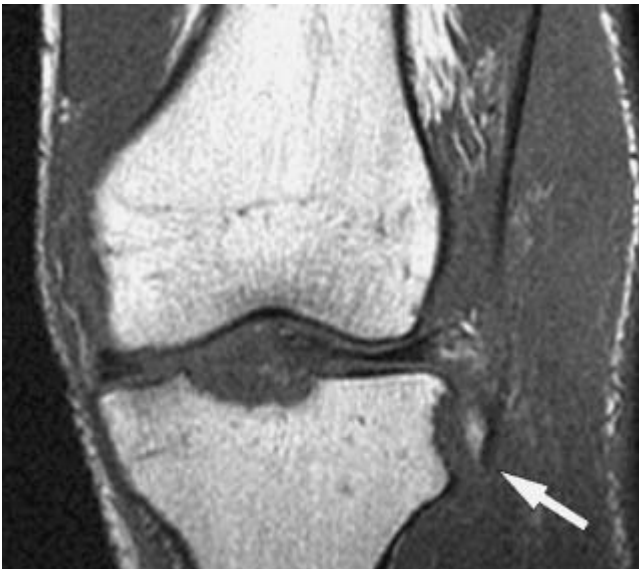
**Figure 8.** Segond fracture. T1-weighted coronal image of the left knee demonstrates a Segond fracture, a capsular avulsion fracture (arrow) of the lateral tibial plateau. This fracture correlates highly with a tear of the ACL. An ACL tibial avulsion is also present in this case.

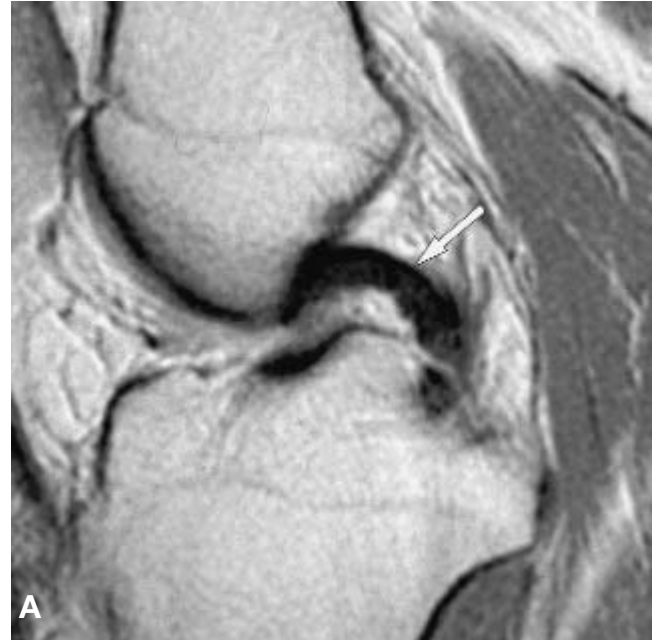
**Figure 9.** Normal MR appearance of the PCL. A, B, consecutive T2-weighted sagittal images demonstrate the normal PCL (arrows) as a thick, arcuate-shaped, band-like structure of low intensity that extends from the intercondylar portion of the medial femoral condyle to the posterior sloping aspect of the tibial plateau.

or more commonly on 2 consecutive sagittal images (Figures 9 A and B). Axial and coronal planes are complementary but rarely necessary in the evaluation of the PCL.

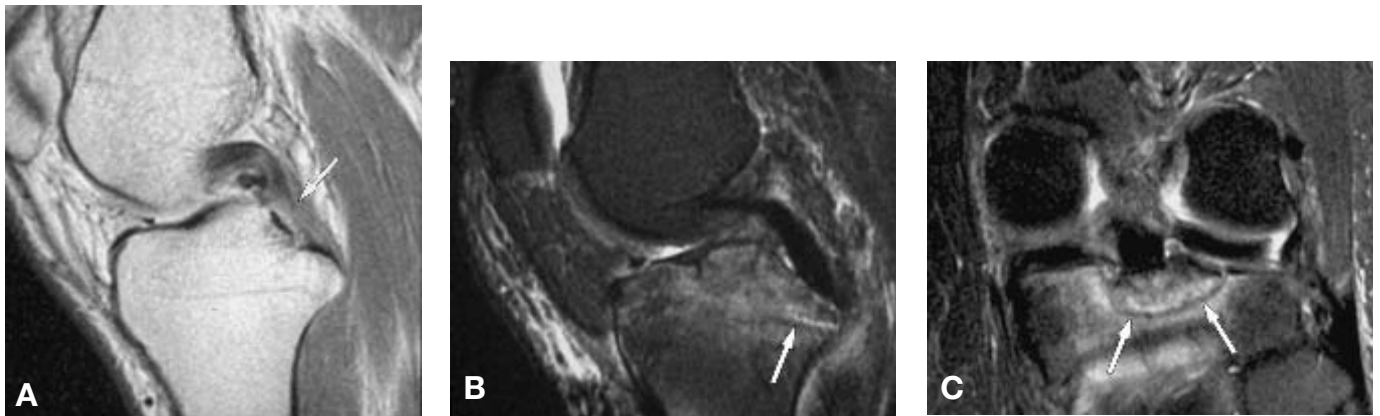
**Figure 11.** PCL injury patterns. A, T2-weighted sagittal image demonstrates high signal within the midsubstance of the PCL; however, some fibers remain intact. This is consistent with a partial-thickness tear (arrow). B, C, T2-weighted sagittal and coronal images of the left knee demonstrate an avulsion fracture (arrows) of the posterior tibial plateau at the insertion site of the PCL.

- Complete tear: high signal completely traversing the fibers of the PCL on T2-weighted images (most commonly occurs in the midsubstance) (Figure 10B).
- Partial tear: high signal incompletely traversing the fibers of the PCL on T2-weighted images (Figure 11A).

- Bone marrow edema (BME) involving the anterior proximal tibia (Figures 10 A and B).
- Avulsion of the posterior tibia at the PCL insertion site (Figures 11 B and C).

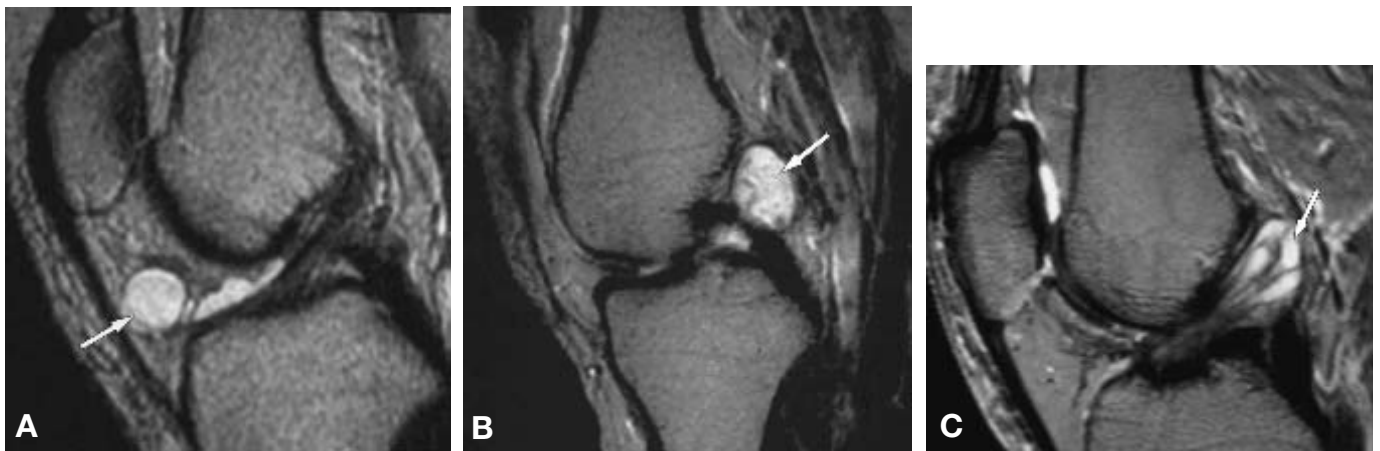
**Figure 12.** Cruciate cysts. A, T2-weighted sagittal image demonstrates a cruciate cyst (arrow) arising from the anterior surface of the ACL and extending into the infrapatellar fat pad. B, T2-weighted sagittal image in a different patient demonstrates a cruciate cyst arising from the PCL. C, T2-weighted sagittal image demonstrates a cruciate cyst arising within the substance of the ACL. This type of cruciate cyst splays and displaces the fibers of the ACL and can mimic a tear of the ACL.

Cruciate ligaments are intracapsular structures that are enveloped within a fold of synovium. Ganglia originate from the synovial lining of the ACL or PCL and appear on either the surface (Figures 12 A and B) or within the substance of the ligament (Figure 12C). Large cysts can extend into the joint posteriorly, extend into the Hoffa fat pad anteriorly, or occasionally erode into adjacent bone. Cruciate cysts may be identified incidentally on MRI, or they may cause the symptoms of catching, locking, or pain. The cysts are usually well defined, septated, and oval or lobular in appearance, and they follow water signal on all pulse sequences. A cruciate cyst arising on the surface of the ligament may mimic a meniscal cyst, whereas one arising within the substance of the cruciate ligament can mimic a cruciate ligament tear on MRI.<sup>12</sup>

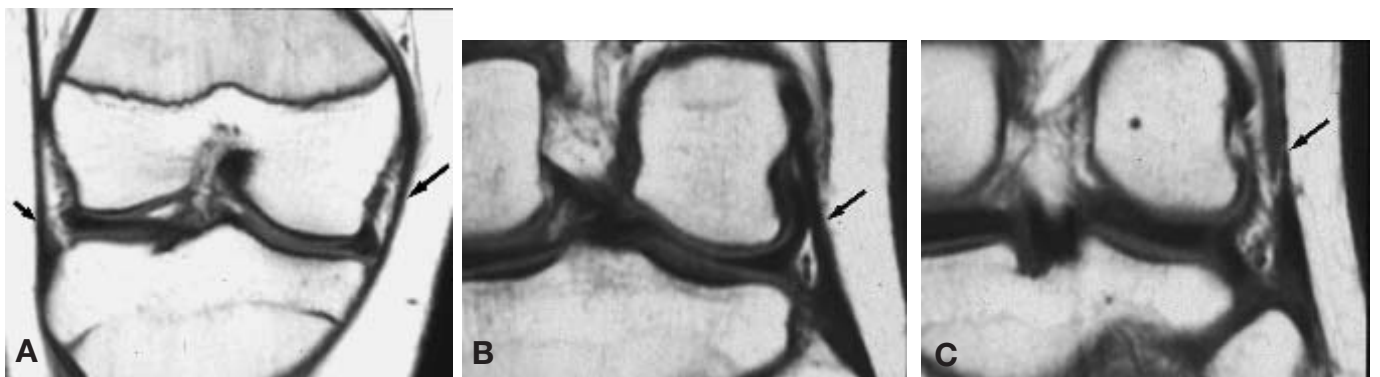
**Figure 13.** Normal MR appearance of the collateral ligament complexes. T1-weighted coronal images demonstrate (A, right knee) the normal MR appearance of the medial collateral ligament (long arrow) and iliotibial band (short arrow), (B, left knee) normal fibular collateral ligament (arrow), and (C, left knee) normal biceps femoris tendon (arrow).

The collateral ligaments are best evaluated on the T2-weighted coronal images of the knee. The MCL is composed of 2 layers: (1) the deep fibers that attach to the capsule and the medial meniscus and (2) the superficial fibers. The tibial collateral bursa is a potential space between the 2 layers. This can sometimes become inflamed and filled with fluid. The MCL is 8 to 10 cm in length and extends from the medial femoral condyle to insert 4 to 5 cm below the joint line on the medial tibia, posterior to the attachment of the pes anserine tendons (Figure 13A).<sup>3,28</sup>

The LCL complex is composed of several individual structures: (1) the fibular collateral ligament (Figure 13B) extends from the lateral femoral condyle to the fibular head, (2) the biceps femoris tendon (Figure 13C) merges with the fibular collateral ligament to attach on the fibular head as a conjoined tendon, and (3) the iliotibial band (Figure 13A), an extension of the tensor fascia lata, attaches on the anterior tibia.<sup>23</sup>

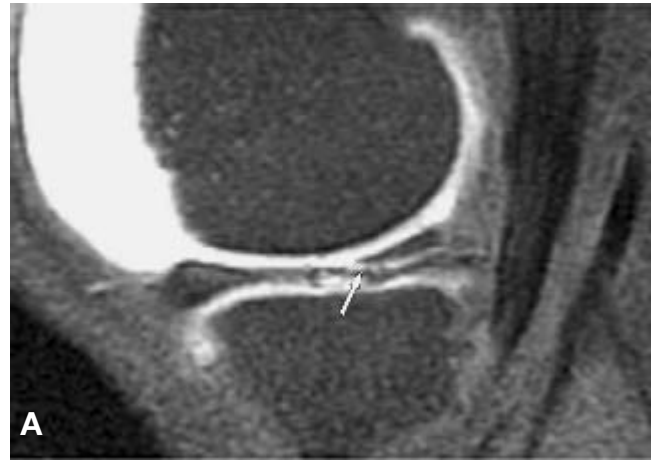
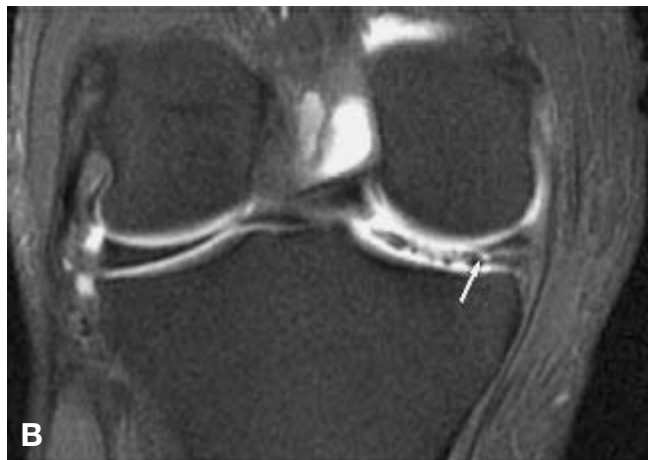
**Figure 25.** Recurrent tear of a postoperative meniscus on MR arthrogram. T1-weighted sagittal (A) and coronal (B) images of the right knee on a direct MR arthrogram demonstrate contrast (arrows) extending into the substance of the meniscus, consistent with a recurrent tear.

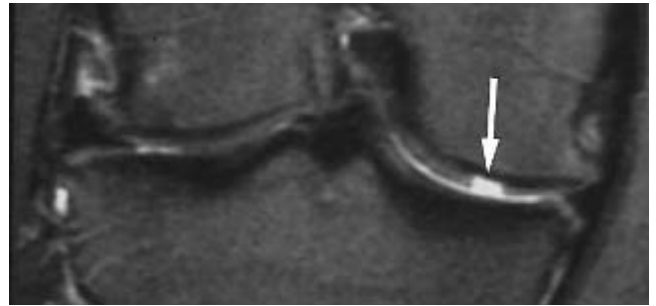
**Figure 28.** Articular cartilage defect. T2-weighted coronal image of the right knee demonstrates a full-thickness defect (arrow) of the medial femoral condyle articular cartilage. On a fat-saturated T2-weighted image, the normal articular cartilage is intermediate in signal intensity, the cortex is black, and fluid is bright.

Cartilage appears intermediate in signal intensity on T2-weighted or proton density images with fat saturation. It is clearly distinguishable from the dark signal of the adjacent osseous cortex and the bright signal of joint fluid (Figure 28). Cartilage defects of the tibia or femur are best seen on the sagittal and coronal images, whereas patellar abnormalities are best demonstrated on the axial images. Several cartilage-specific sequences have been developed to aid in the evaluation of articular cartilage of the knee, and although the accuracy for demonstrating lesions of the articular cartilage varies greatly depending on the equipment and pulse sequences used, studies have shown that using cartilage-specific imaging techniques can result in a sensitivity of 93% and a specificity of 94% for demonstrating arthroscopically visible lesions.<sup>6</sup>
